**The Kangiqsujuaq Quarry Site (JjEx-17):
Expertise and Evaluation**

AVATAQ CULTURAL INSTITUTE

June 1996

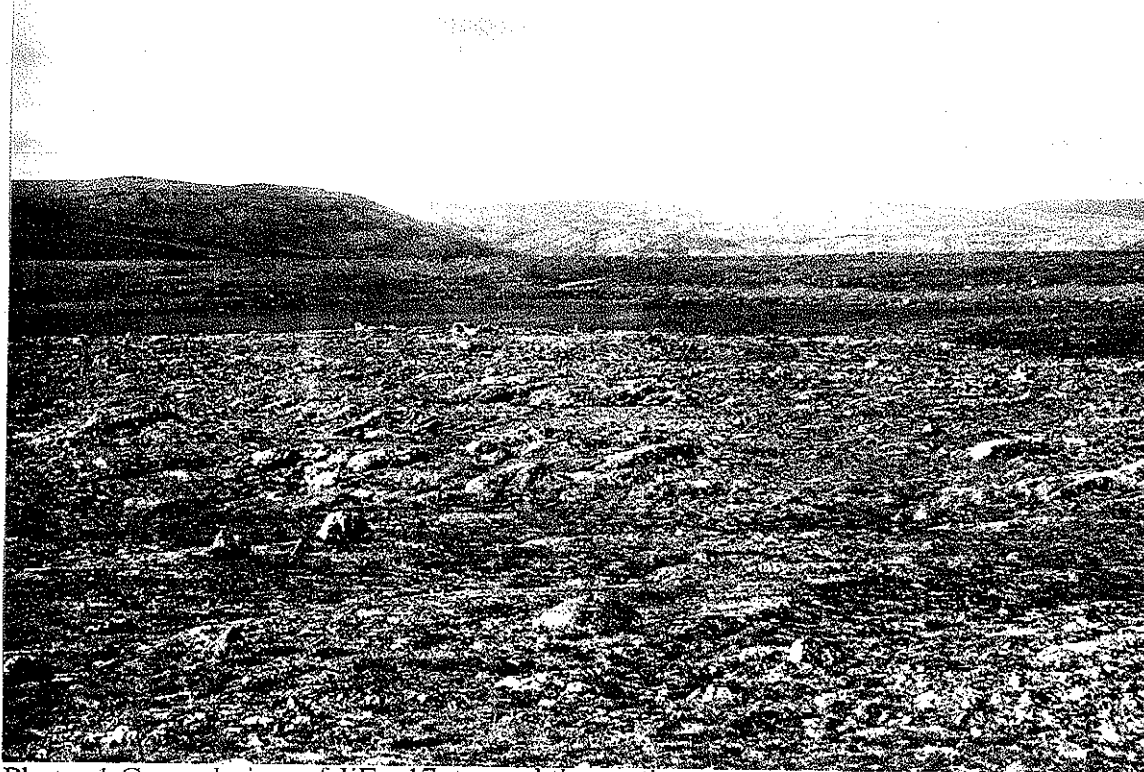
Photo. 1. General view of JjEx-17, toward the north.

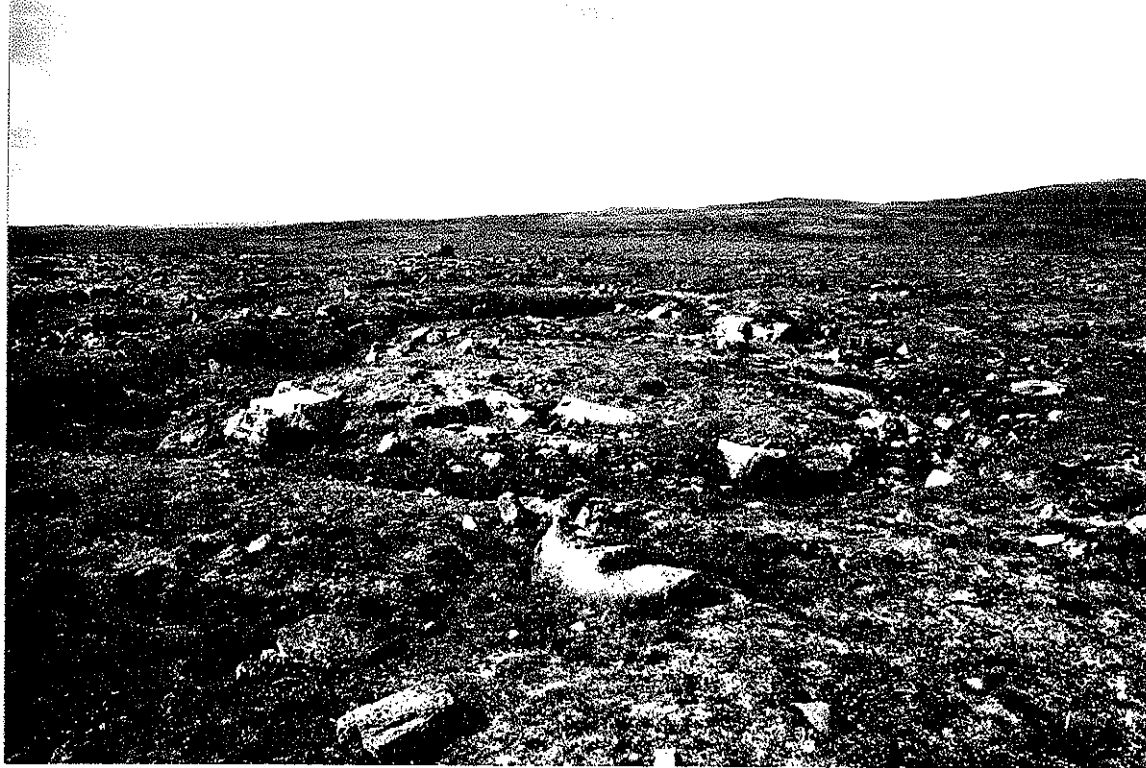
The portion of the quarry that has been unearthed measures 9.60 x 17.10 m and is oriented W-E. It affects a roughly rectangular shape. Because of the excavation that took place, it is hard now to imagine how the quarry looked after it was abandoned. However, it is suggested that the area that has been unearthed recently must correspond to the area that was once used. Vegetation cover in portions of the unearthed area would confirm that parts of the quarry were already open when it was found in the Fall of 1994. This would also confirm that the prehistorically exploited area would be essentially the same as the one visible today, although it appears that the soapstone outcrop does continue further toward the west-northwest.

Photo. 2. Overview of the quarry, toward the west.

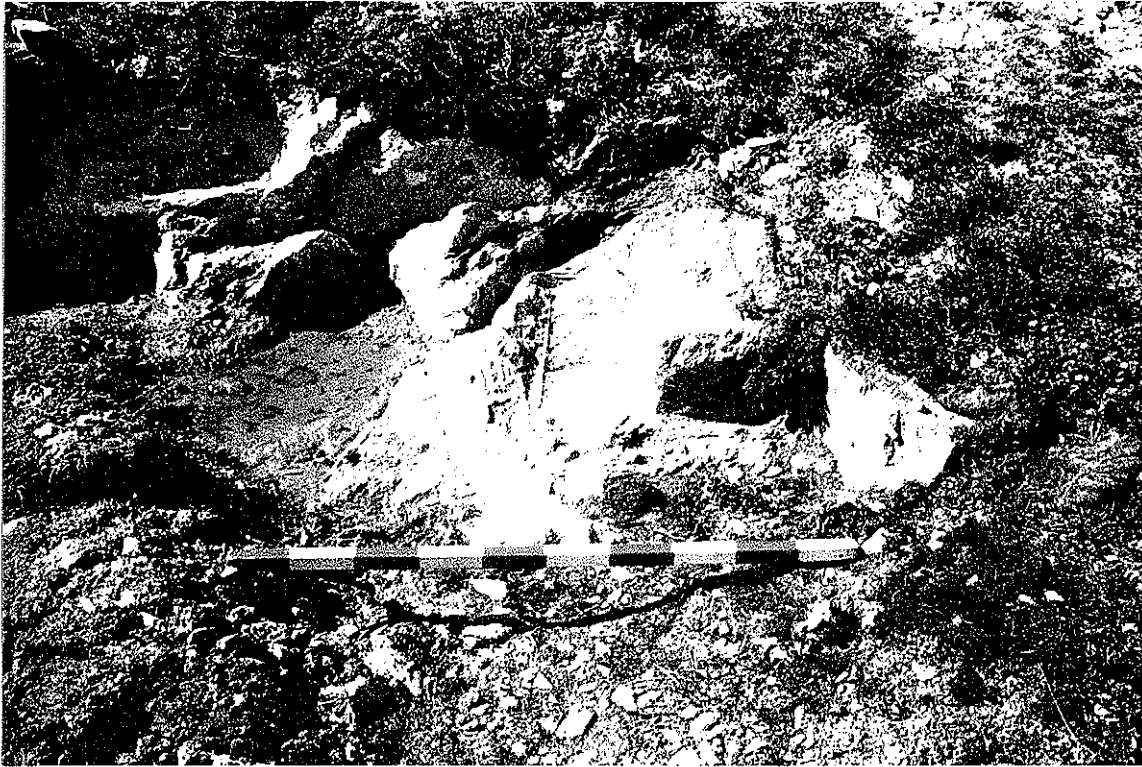
Zone 2 is located at the northwestern extremity. At this location, one can see the marks left by the

extraction of a large soapstone block. Surrounding this extraction zone are intact portions of the outcrop. Here again, marks of recent scraping are visible just below the extracted block.

Zone 3 occupies most of the western limit of the quarry. This soapstone wall is mostly intact except for its northern extremity located next to **zone 2**. A soapstone block was removed prehistorically from that portion of the wall. The wall shows traces of recent punctual scraping.

Photo. 3. Extraction zone 2 and northern portion of zone 3, toward the west.

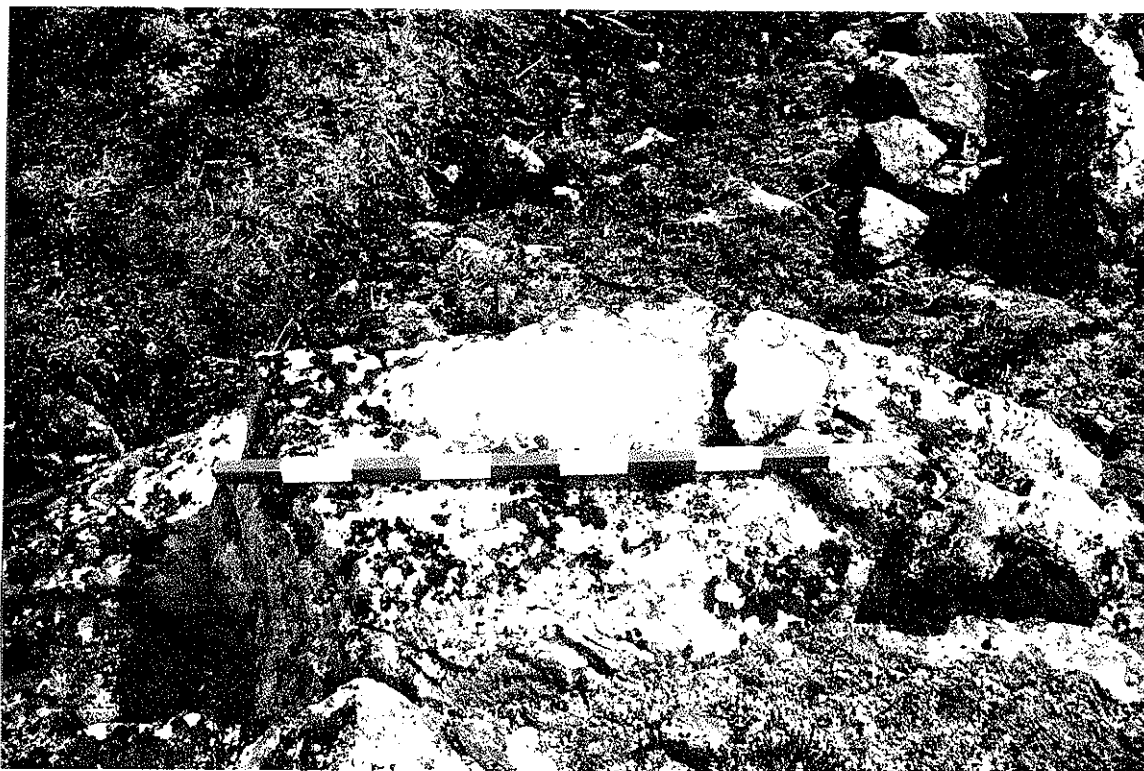
Another feature was observed a few metres south of the quarry. An outcrop roughly 1.50 m long and 1.00 m wide showed evidence of heavy polishing over an area of 0.50 x 0.50 m. Scattered soapstone blocks in this area suggest that this outcrop was used as an abrader. On the photograph, a small piece of soapstone was left beside the abrading zone. However, we suspect that this piece was put there recently by the carver who discovered the site. In a filmed interview done by T.N.I. (See transcript in Appendix), we see him use this piece to illustrate the use of the outcrop.

Photo. 5. Bedrock outcrop used as an abraded, toward the southeast.

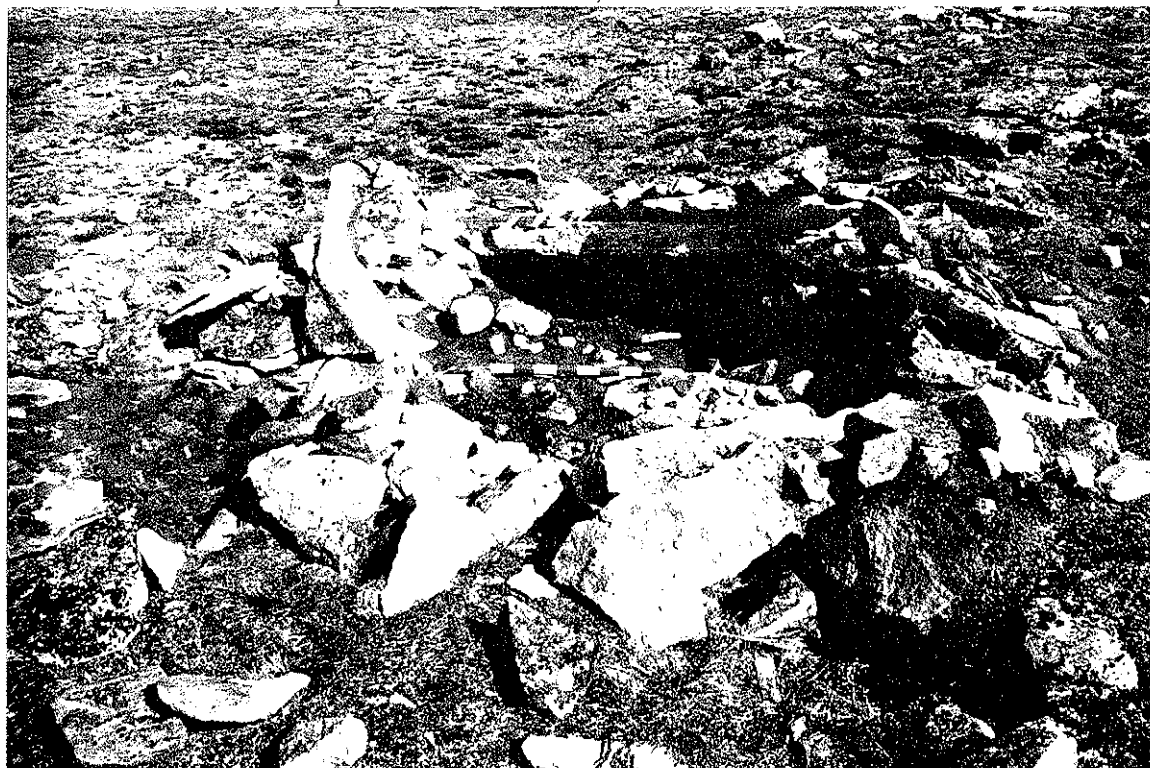
Structure 1 measures 2.40 x 2.80 m oriented NE-SW. Its eastern wall encompasses a bedrock outcrop. The southern and western walls are comprised of several layers of rocks. The northern extremity was the entrance. The interior and the area immediately in front of the entrance have been entirely excavated. Rocks that might have belonged to a pavement have been deposited on top of the structure's walls. Some artefacts were left in piles on the rock walls.

Photo. 6. General view of Structure 1, toward the east.

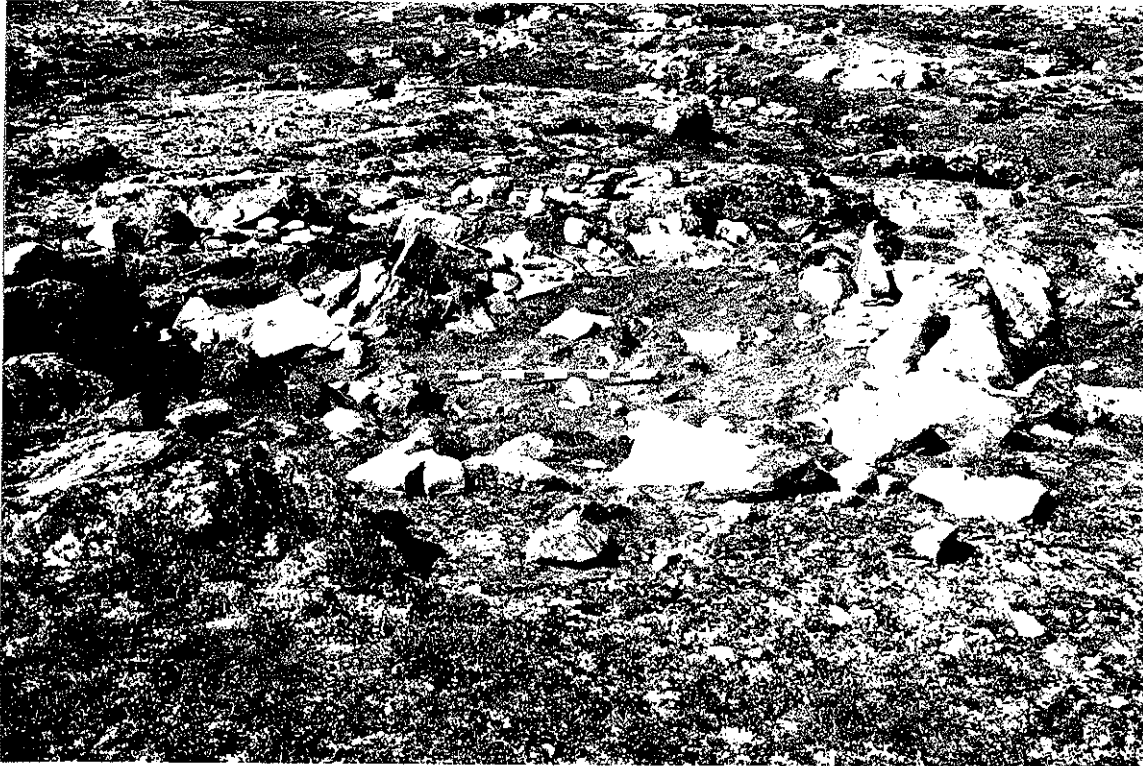
Structure 2 measures 3.90 x 4.80 m and is oriented NNW-SSE. A small annex (1.50 x 2.30 m) is located along the eastern wall of the structure. The western and southern walls encompass an 'L-shaped' bedrock outcrop. The eastern wall appears to have been constructed with several rows of rocks. An opening occupies the northern extremity. The annex is delimited by a row of smaller rocks. No entrance are visible. Both the structure and the annex have been totally excavated. Rocks that originally composed the pavement (inside the structure) have been turned upside, and others have been tossed on the walls. Artefacts have also been piled on the walls, and some bones were still visible where once was the floor.

Photo. 7. General view of Structure 2, toward the northwest.

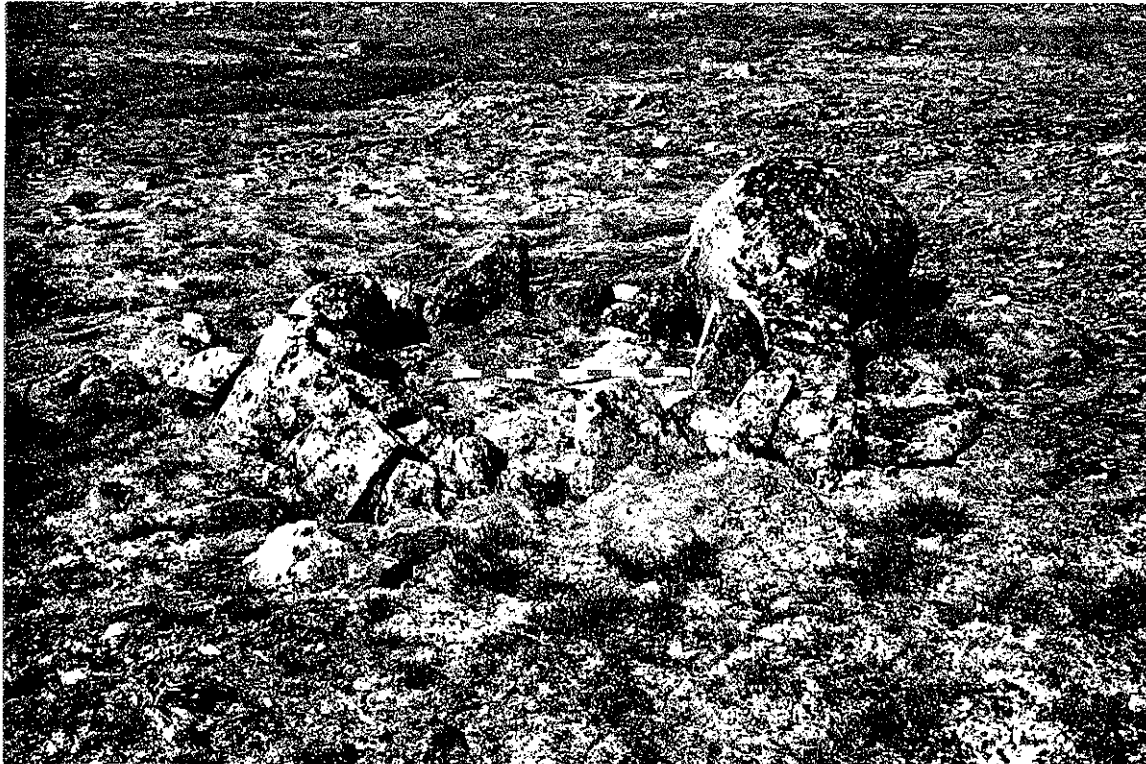
Structure 7 measures 1.80 x 2.10 m and is oriented NW-SE. The outer walls are composed of medium-sized boulders, and an erratic marks the northeastern limit. To the southwest, an opening is visible. This being the only structure that remains intact, the interior was covered by moderate to dense vegetation. No pavement was observed in this dwelling. Structurally, its construction does not appear as sophisticated as the other ones.

Photo. 8. General view of Structure 7, toward the northwest.

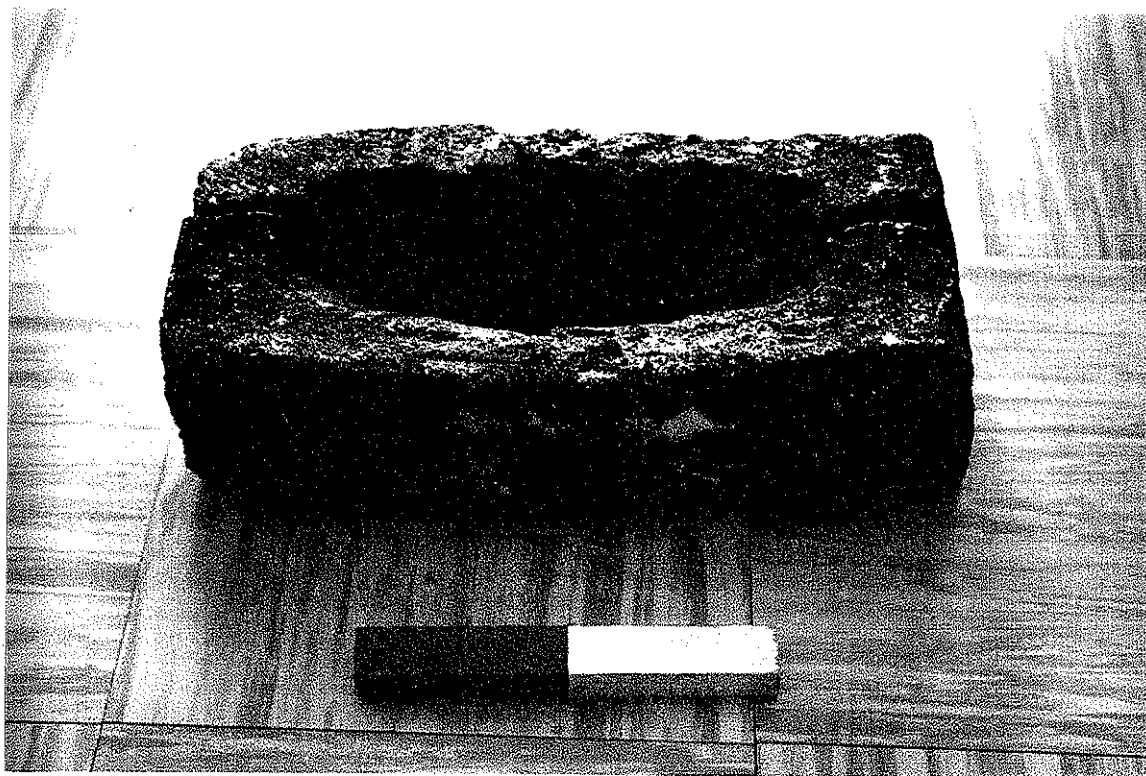
Photo. 9. One of the object retrieved from the site. Possibly a pot preform.

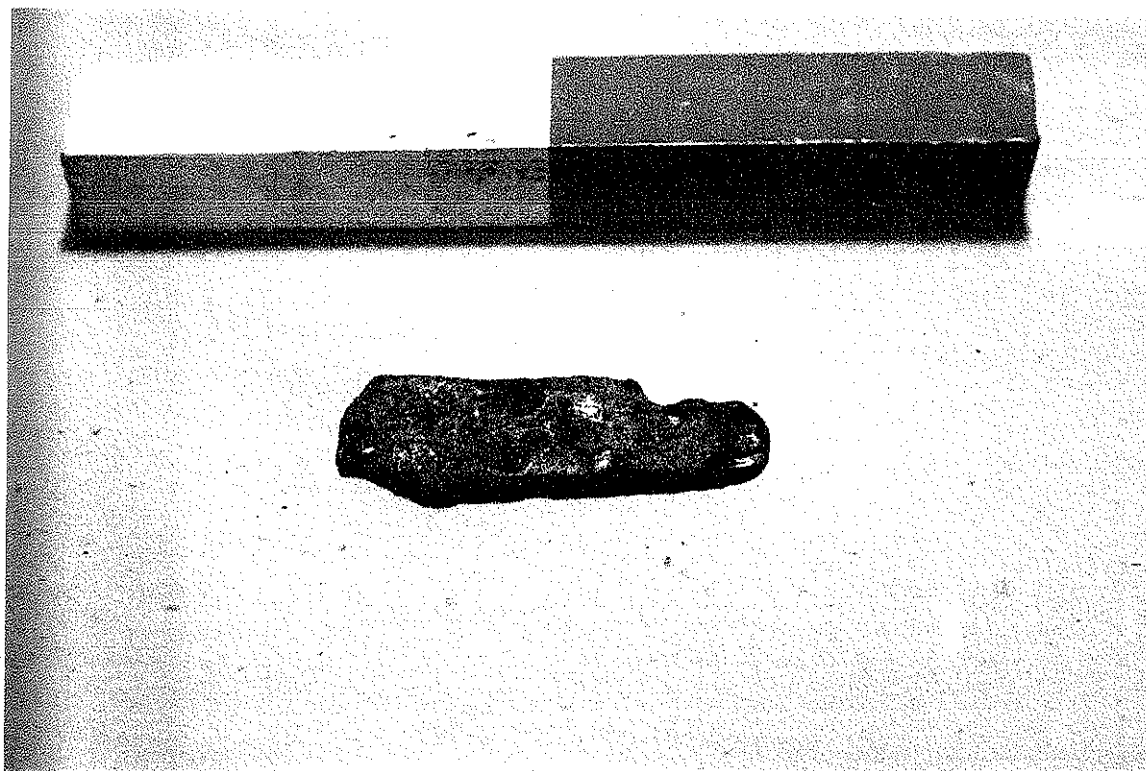
We have been able to see some of the objects that were collected by members of the Community. Most of the objects were incomplete bowl or lamp fragments, one bone knife handle, and one piece of metal, probably iron. This last piece measured approximately 10 cm long and 2 cm wide. The surface was entirely corroded, but it affected a blade-like shape. One of the extremity had been recently filed exposing the metal. Unfortunately, we weren't able to recuperate this object. It would have been interesting to identify its origin (native iron or traded item ?).

Photo. 10. Metal object retrieved from the site. The right extremity has been recently filed.
